MISCELLANEOUS PAPER SL-80-8

**CONCRETE AND ROCK TESTS
MAJOR REHABILITATION, DRESDEN ISLAND
LOCK AND DAM, ILLINOIS WATERWAY
CHICAGO DISTRICT, PHASE I REHABILITATION**

Structures Laboratory
U. S. Army Engineer Waterways Experiment Station
P. O. Box 631, Vicksburg, Miss. 39180

September 1980

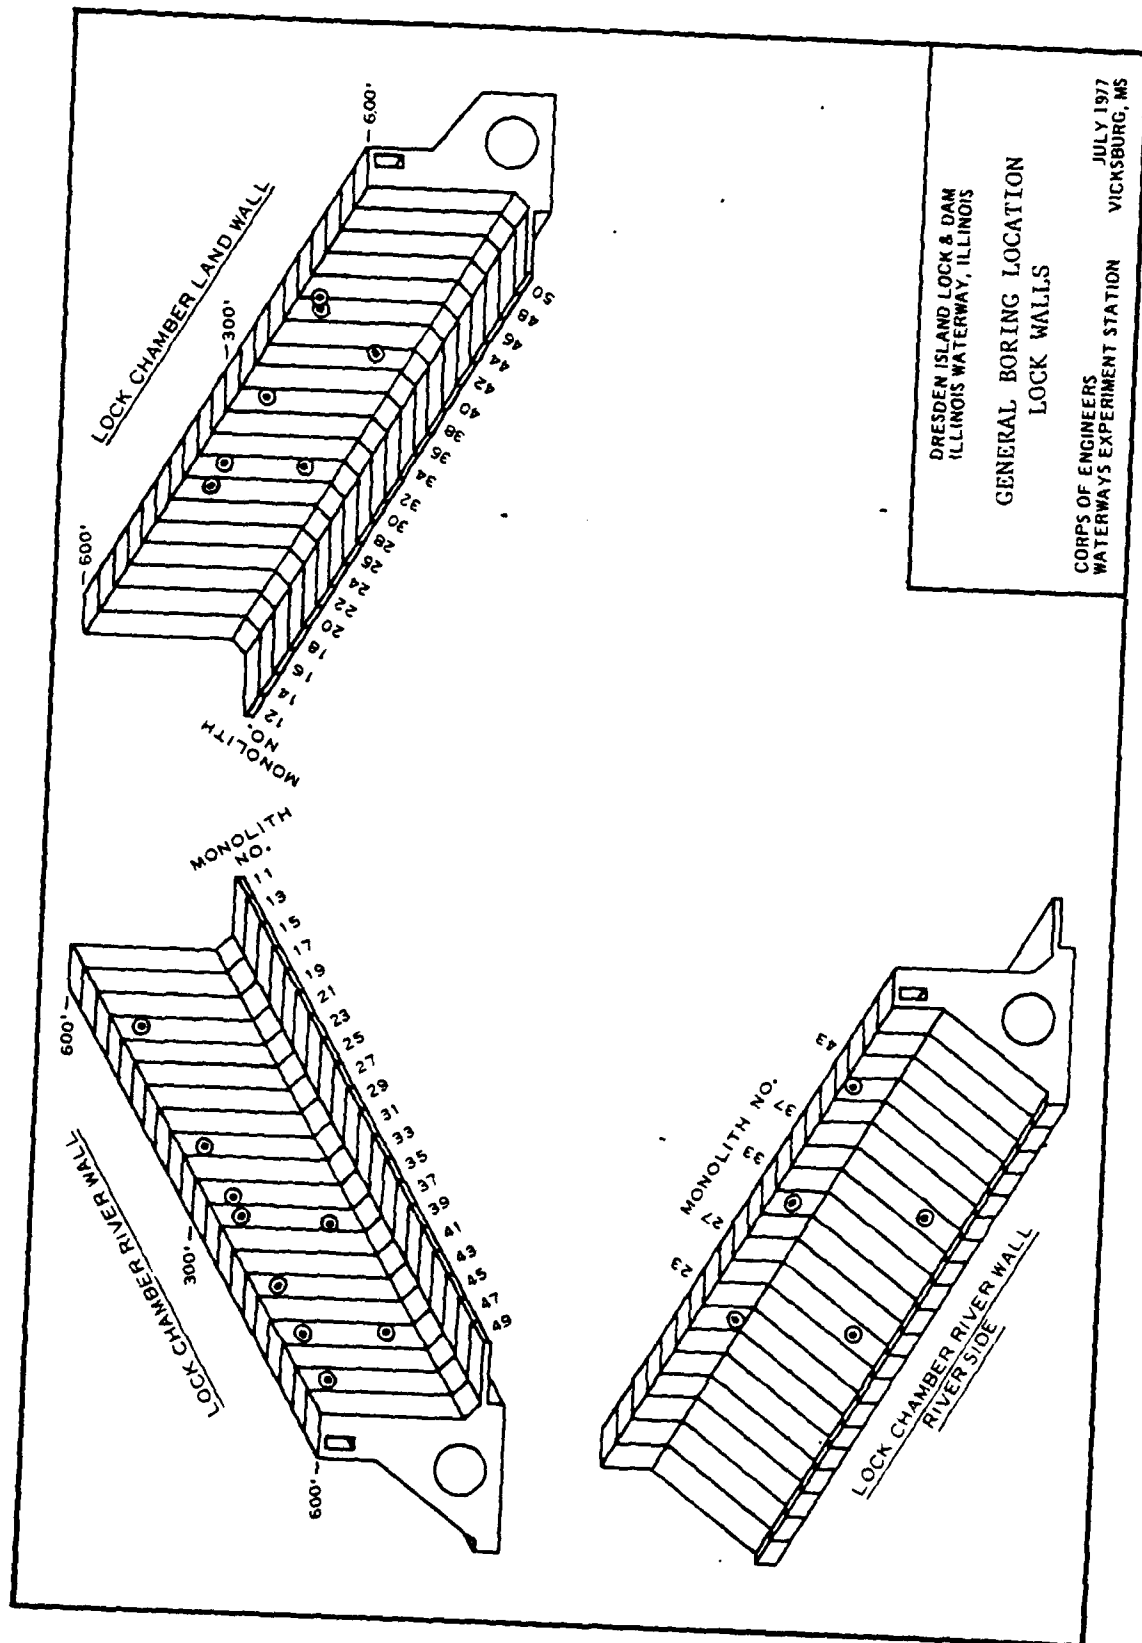
64. Depth of deterioration. The average depth of concrete deterioration through the eroded portion of the wall is 0.7 ft; the maximum depth is 1.2 ft (see Figure 8 for depth of deteriorated concrete for each hole). Figure 8 is a duplicate of Plate 1 which shows both boring locations and depth of deterioration; it is presented here for continuity. The total depth of deterioration as measured from the original face of the lock wall is the sum of the eroded depth and of the present frost damaged concrete. The deepest damaged concrete is near the top of the wall.

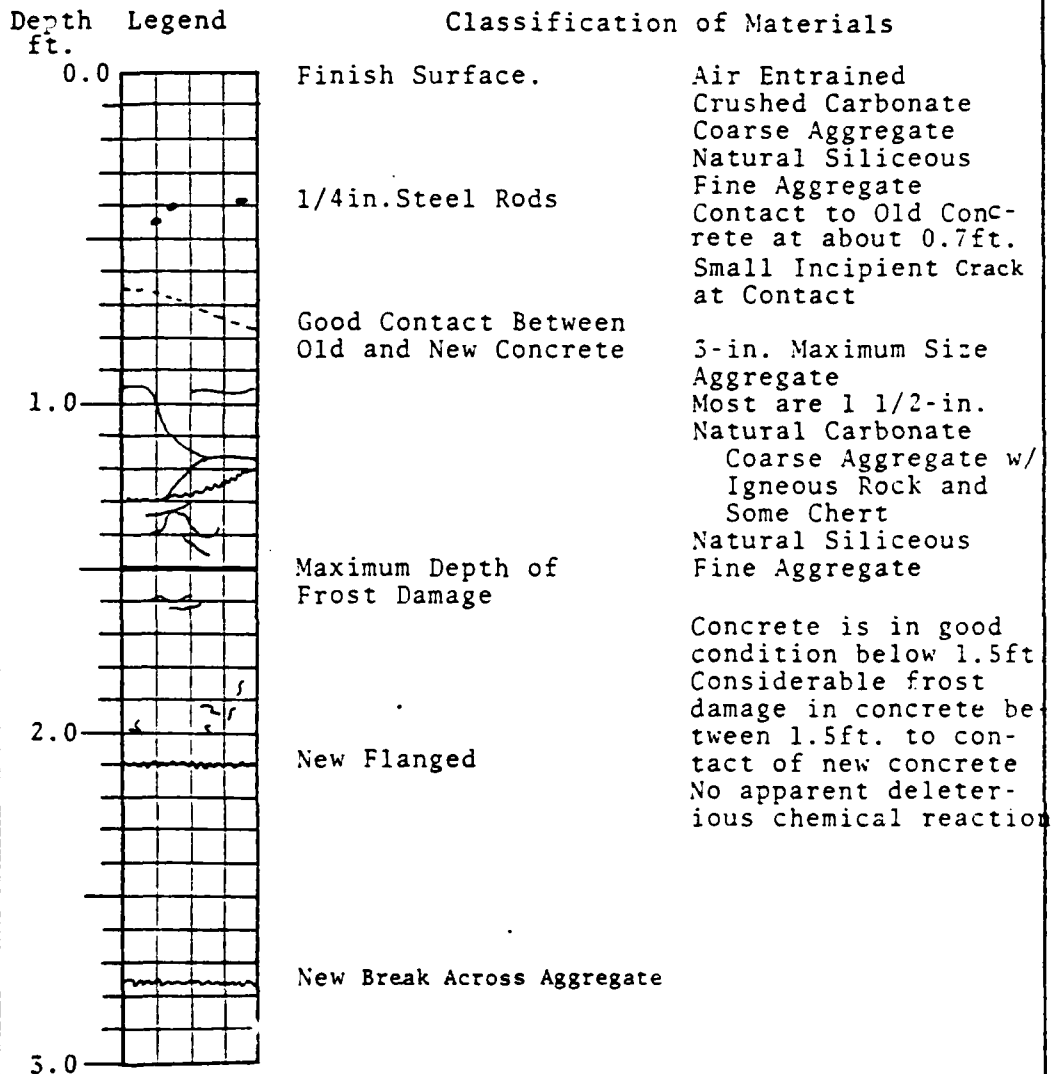
DI WES D-1-77

60. The concrete varied in physical condition. The new concrete was intact and in good condition but as shown in Figure 3 the old concrete in boring D-1 is fractured to a depth of 1.5 ft. This depth is about 0.7 ft below the contact of the new and old concrete. In boring D-6, as illustrated in Figure 4, and in boring GW-5 a crack exists about 0.1 ft deeper than the contact of the old and new concrete. In boring GW-2 an old crack exists at the contact of the old and new concrete. Borings GW-1 and GW-8 were the only other borings with new concrete overlying the old concrete. The concrete was intact and in good condition throughout the entire length of core.
